# Some Test Data on Fireproof Floor Construction

Relating to Cinder Concrete Terra Cotta and Gypsum

# A Fire, Load and Water Test Made Upon Cinder Concrete, Terra Cotta and Gypsum Floor Arches

July 29 — Aug. 1, 1913

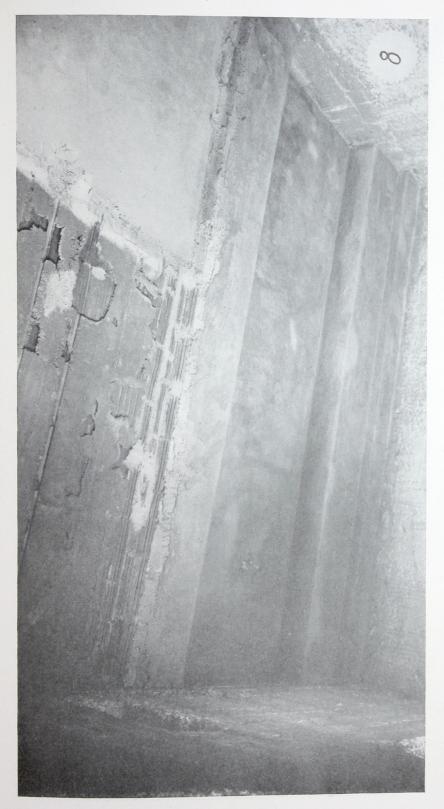
Under Side of Floor with Gypsum Slab in Background, Showing Complete Plaster on this Slab No. 8.

It will be seen from this view and also from Photograph No. 7 that while one-half of the terra cotta and cinder concrete slabs were plastered, the unplastered portion of the terra cotta arch has a very substantial coating of cement mortar. This is mortar which was slushed in under the blocks while the arch was being laid. This mortar was about ½ "thick and, as the photographs show, practically covered all the blocks. This cement mortar no doubt served as a very efficient protection to the blocks against the effect of the fire.

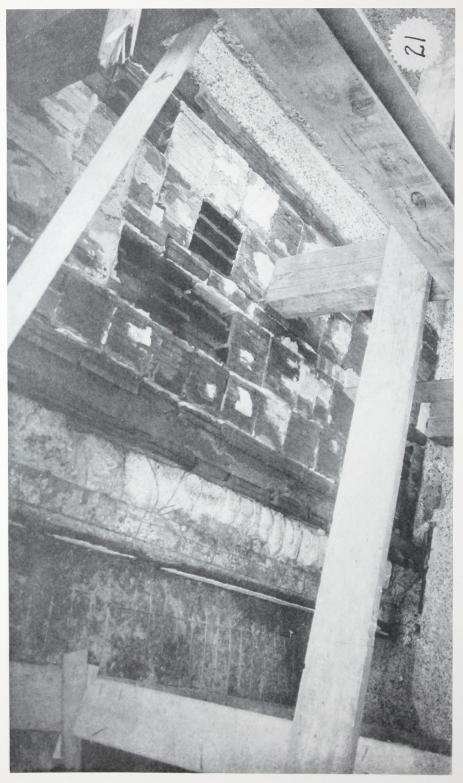
No. 21. Terra Cotta Slab after Load and Sound Test

At completion of load test the under surface of the arch was examined carefully. It was found that well over 75% of the lower faces were unsound, portions of which could be easily removed by hand. Photo 21 was taken after this examination. Practically the entire load was being carried by the central webs and upper faces of the blocks, many of the lower faces being entirely loose, but keved in by the remaining mortar joints.

After the final load of 600 pounds per square foot was applied, the under surface of the terra cotta slab was carefully examined. More than 15% of the lower webs of the blocks were found to be unsound and portions could be easily removed by hand.
